**CORNERSTONE INNOVATIONS, INC.  
CASE STUDY – PERMAFORM  
HOLMES TESTING, INC.  
170 SHEPARD AVENUE  
WHEELING, ILLINOIS**

Re: Summary of Results for the Permaform Case Study, Holmes Testing Laboratories, Wheeling, Illinois

Case Study, Cornerstone, Permaform – Temperature Testing, Wheeling, Illinois

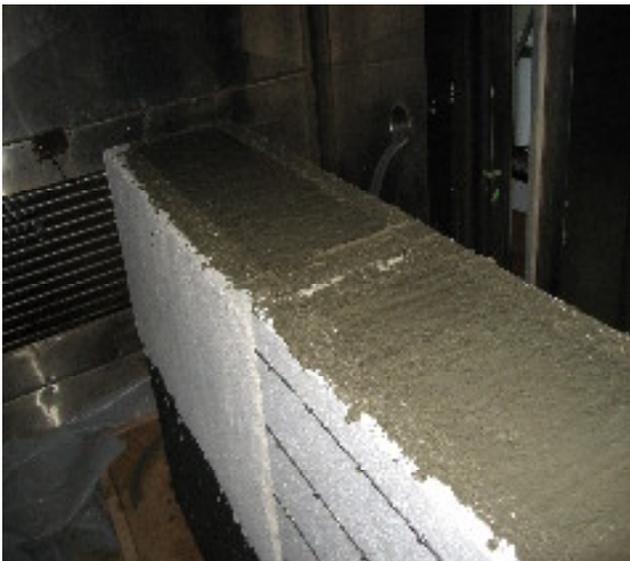
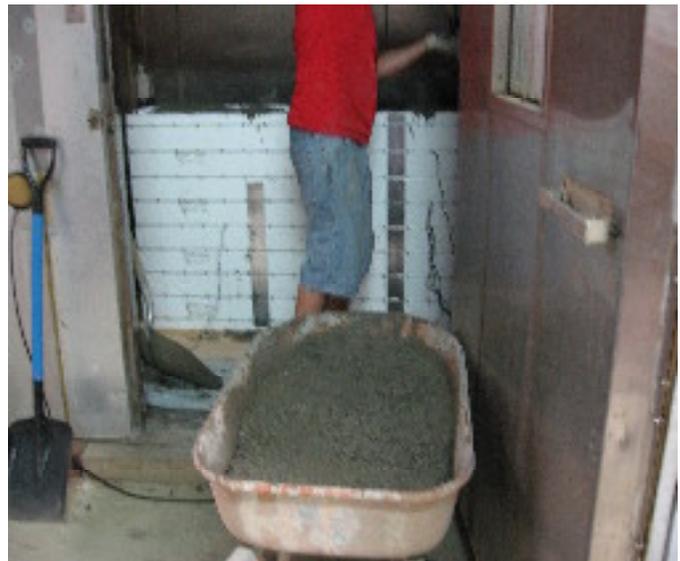
*The construction of the concrete wall with the Permaform*

Holmes Testing, Inc. (Holmes) used an environmental chamber to simulate winter conditions. The door of the environmental chamber was removed and replaced with the concrete filled Permaform on the bottom half and fiberglass insulated standard drywall on the top half. The Permaform was filled in with concrete from Meyer Material Company with a mix designation of 9030L. No concrete was present on the fiberglass half of the wall. A sand bed was placed underneath the wall with a heating element to simulate the temperature of the soils underneath the footings. The sand was able to maintain room temperature without additional heating, therefore the heating element was turned off after a few hours of starting the test.

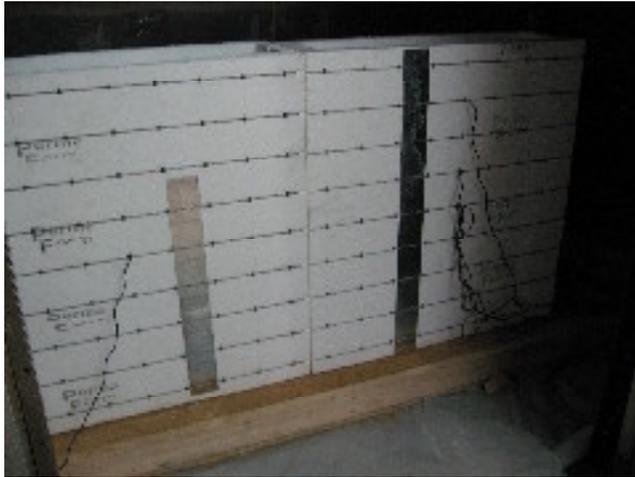
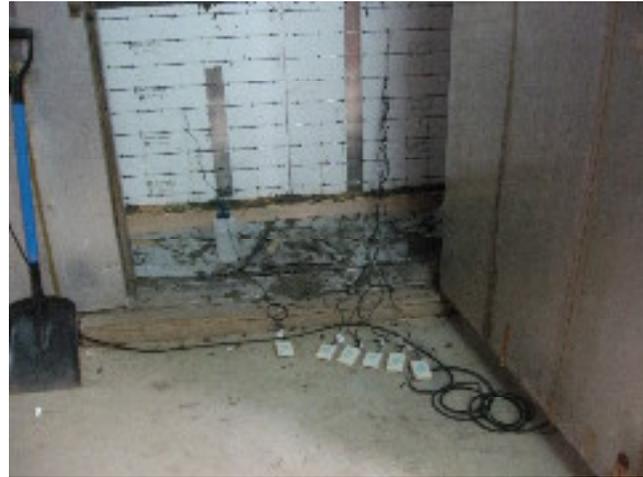
*Installation of the Nomad temperature readers*

Prior to the placement of the concrete, Nomad temperature readers were installed through out the wall to monitor the temperatures. A total of thirteen (13) Nomads were installed, eleven (11) of which were inside the actual wall and the remaining two (2) were used to keep track of the room and chamber temperatures, respectively. The Nomads within the wall were located at the front of the wall (closest to the room), the middle of the wall, and the back of the wall (closest to the chamber) in order to show the temperature profile throughout the wall.

Nomad Number	Description of Location
#1	The back of the Perma board closest to the chamber with no coating
#2	Set in the center of the concrete wall not tied to wire mesh
#3	Tied to the wire mesh on the back of the Perma board closest to the chamber
#4	Tied to the wire mesh at the center of the concrete wall
#5	Tied to the wire mesh at the front of the Perma board closest to the room
#6	Tied to wire mesh at the top center portion of the wall
#7	Inside the wall stud with the Batt fiberglass insulation
#8	In the center of the Batt fiberglass insulation
#9	In the center of the Blowin fiberglass insulation
#10	Inside the wall stud with the Blowin fiberglass insulation
#11	Inside the sand bed underneath the wall
#12	Inside the Chamber
#13	Outside in the Room

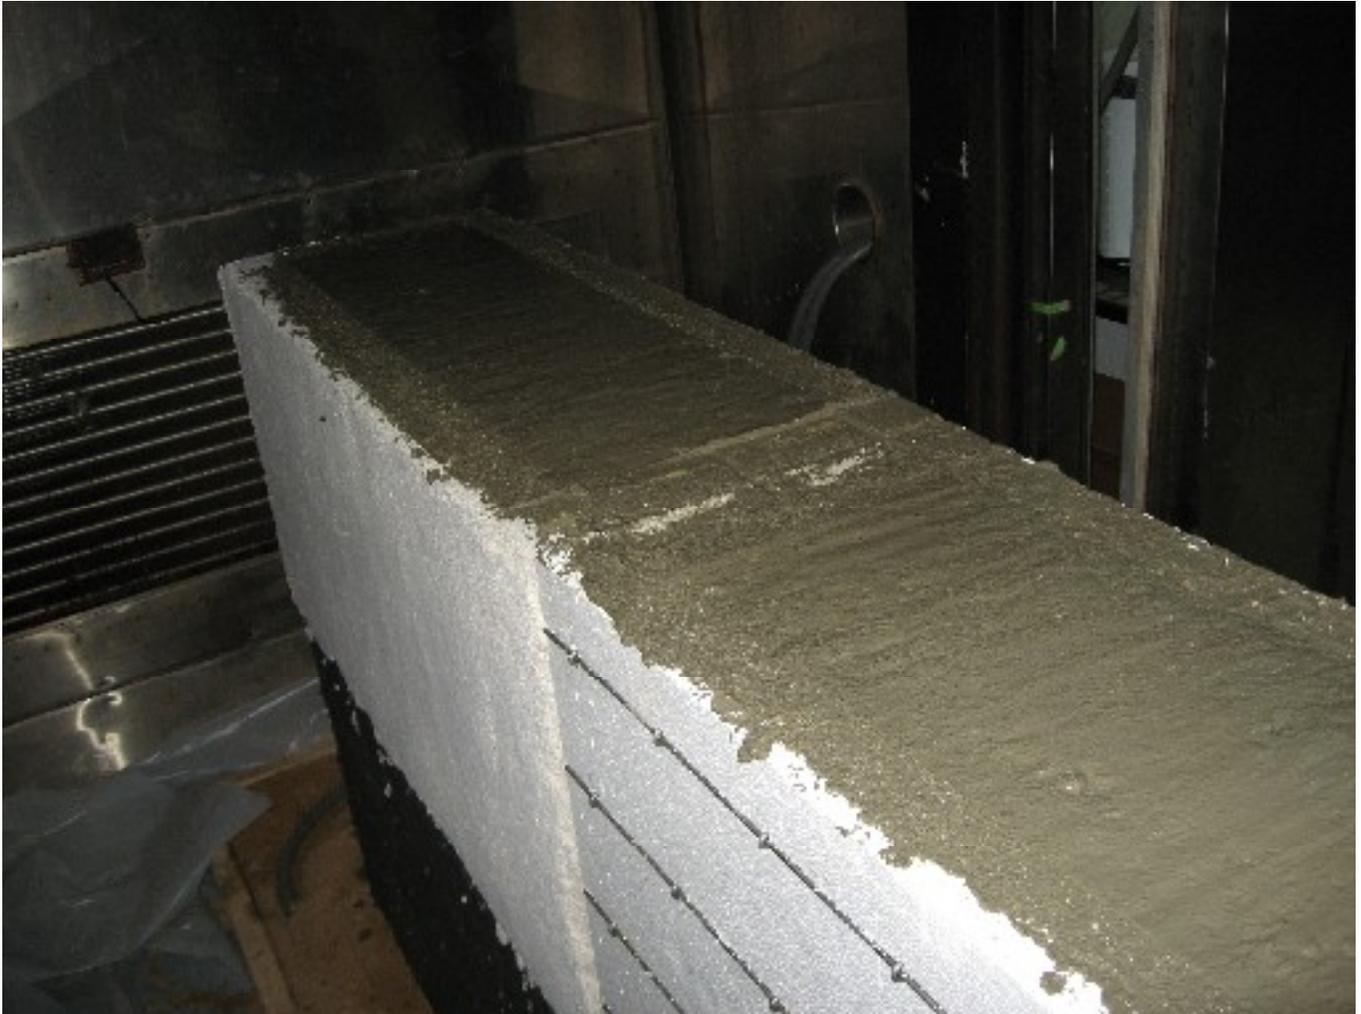
*View from inside of the chamber, bare Permaform wall on the right, Stucco coating on top left, and rubber coating on the bottom left*

The finished wall was sealed to insure that no transfer of heat could take place between the inside of the chamber and the outside room without going through the constructed wall. The finished Permaform wall was divided into three (3) sections; bare wall, Stucco coated, and rubber coated.

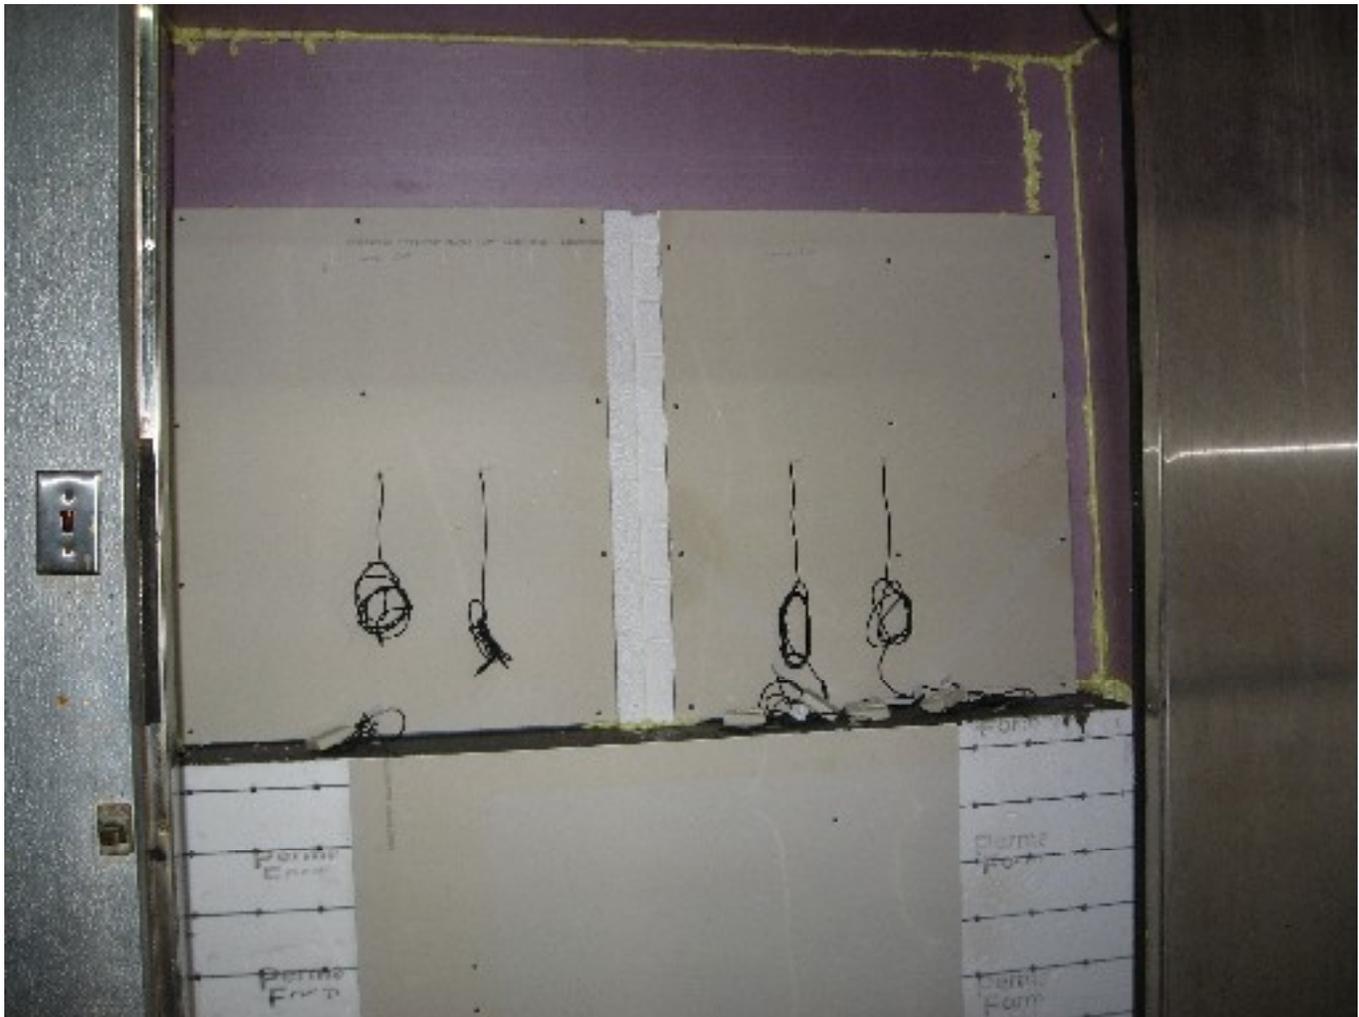
*The upper portion of the wall in this picture contains the fiberglass insulations*

The fiberglass insulated drywall used two different types of fiberglass insulations, the left half used the standard fiberglass insulation while the right half used the blowin fiberglass insulation.

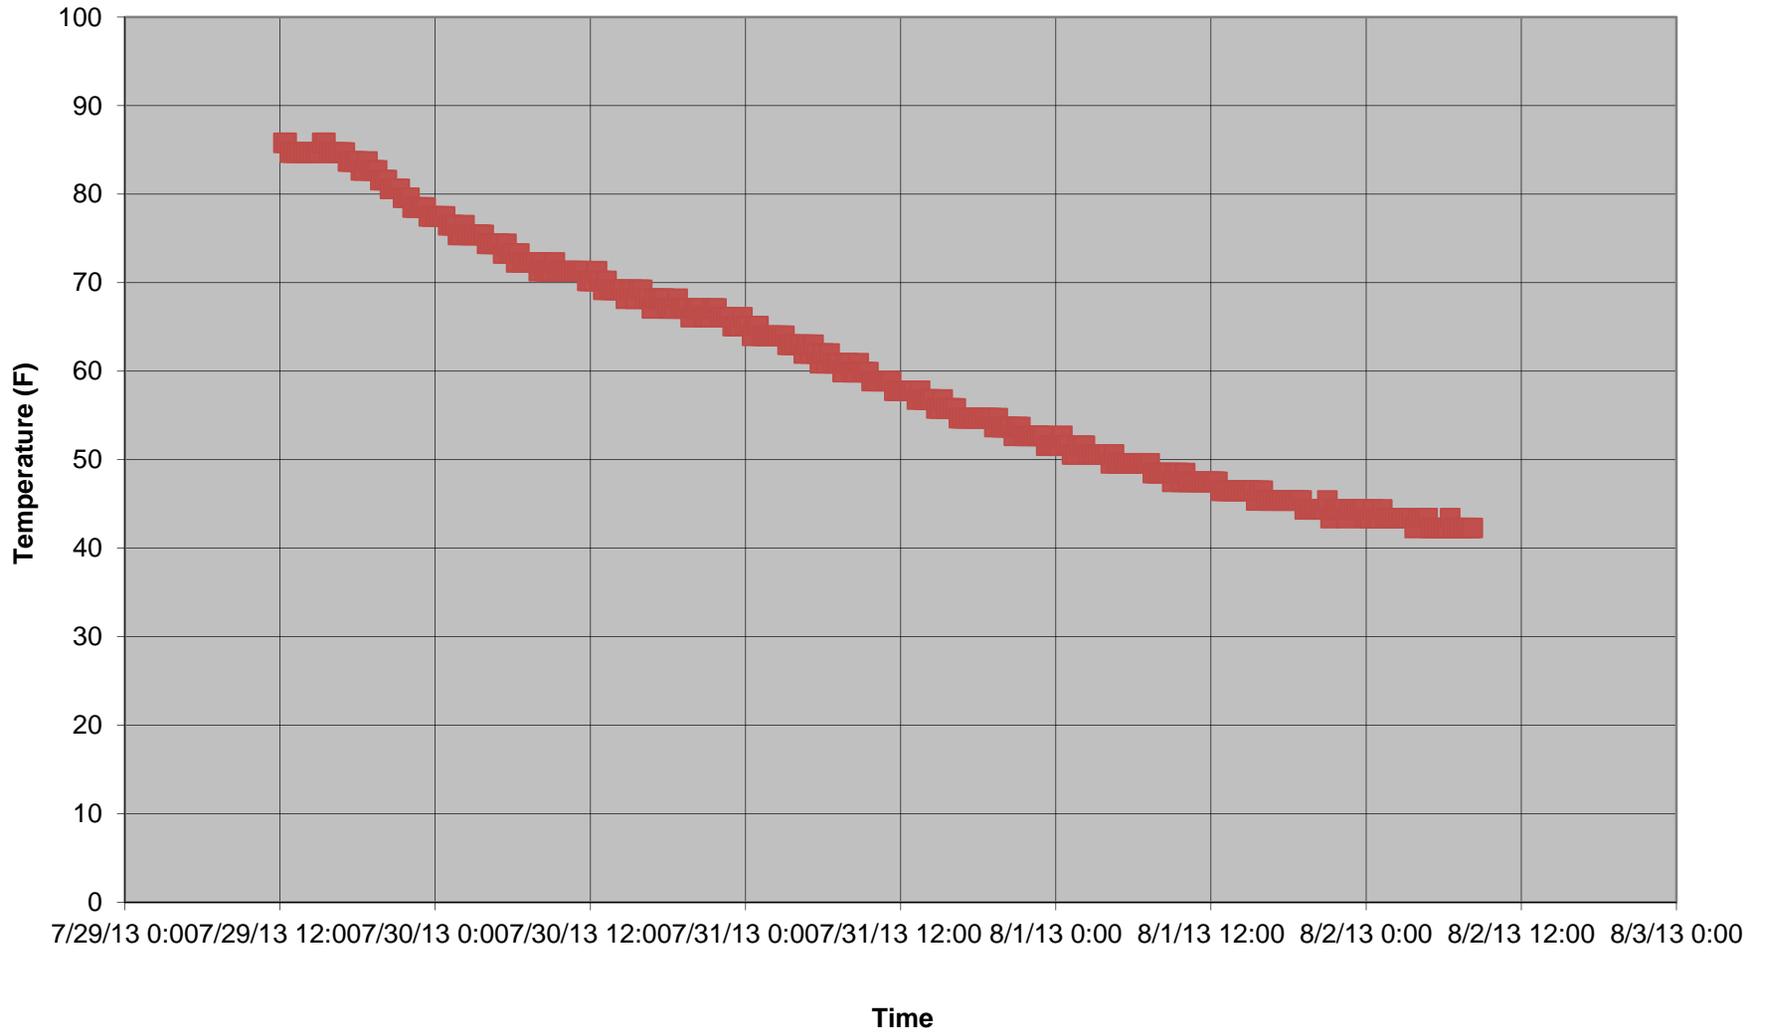
Nomad #1  
Temperature vs Time

The data analysis above and the graph indicate that the temperature began at approximately 85°F and decreased to approximately 42°F over the course of the testing period. We are unable to determine if the final temperature was at equilibrium. Based on the graph it is possible that the temperature would continue to drop and we would recommend that the test be performed for a longer duration until the temperature stabilizes.

Statistic	Value
Minimum	42.3°F
Maximum	85.8°F
Average	60.4°F
Standard Deviation	13.2°F
Sample Variance	173.1

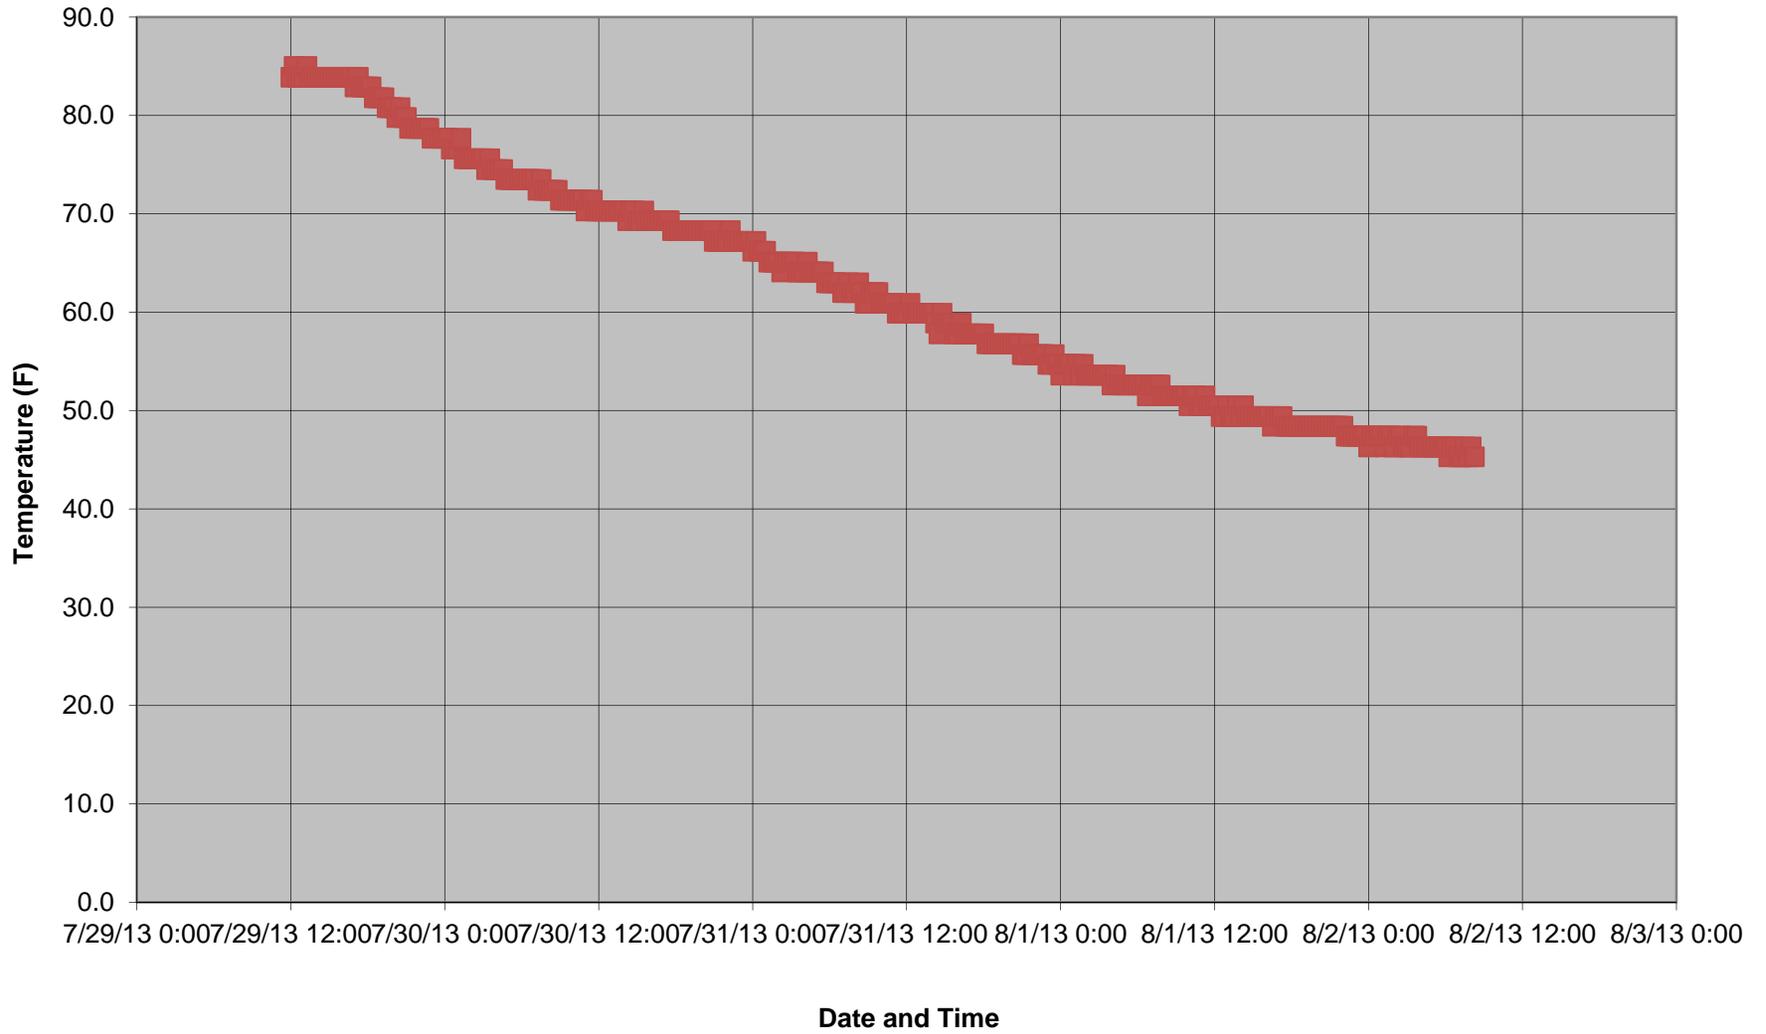
NOMAD #2  
Temperature vs. Time

The data analysis above and the graph indicate that the temperature began at approximately 85°F and decreased to approximately 45°F over the course of the testing period. We are unable to determine if the final temperature was at equilibrium. Based on the graph it is possible that the temperature would continue to drop and we would recommend that the test be performed for a longer duration until the temperature stabilizes.

<b>Statistic</b>	<b>Value</b>
Minimum	45.3°F
Maximum	85.0°F
Average	62.2°F
Standard Deviation	11.7°F
Sample Variance	136.9

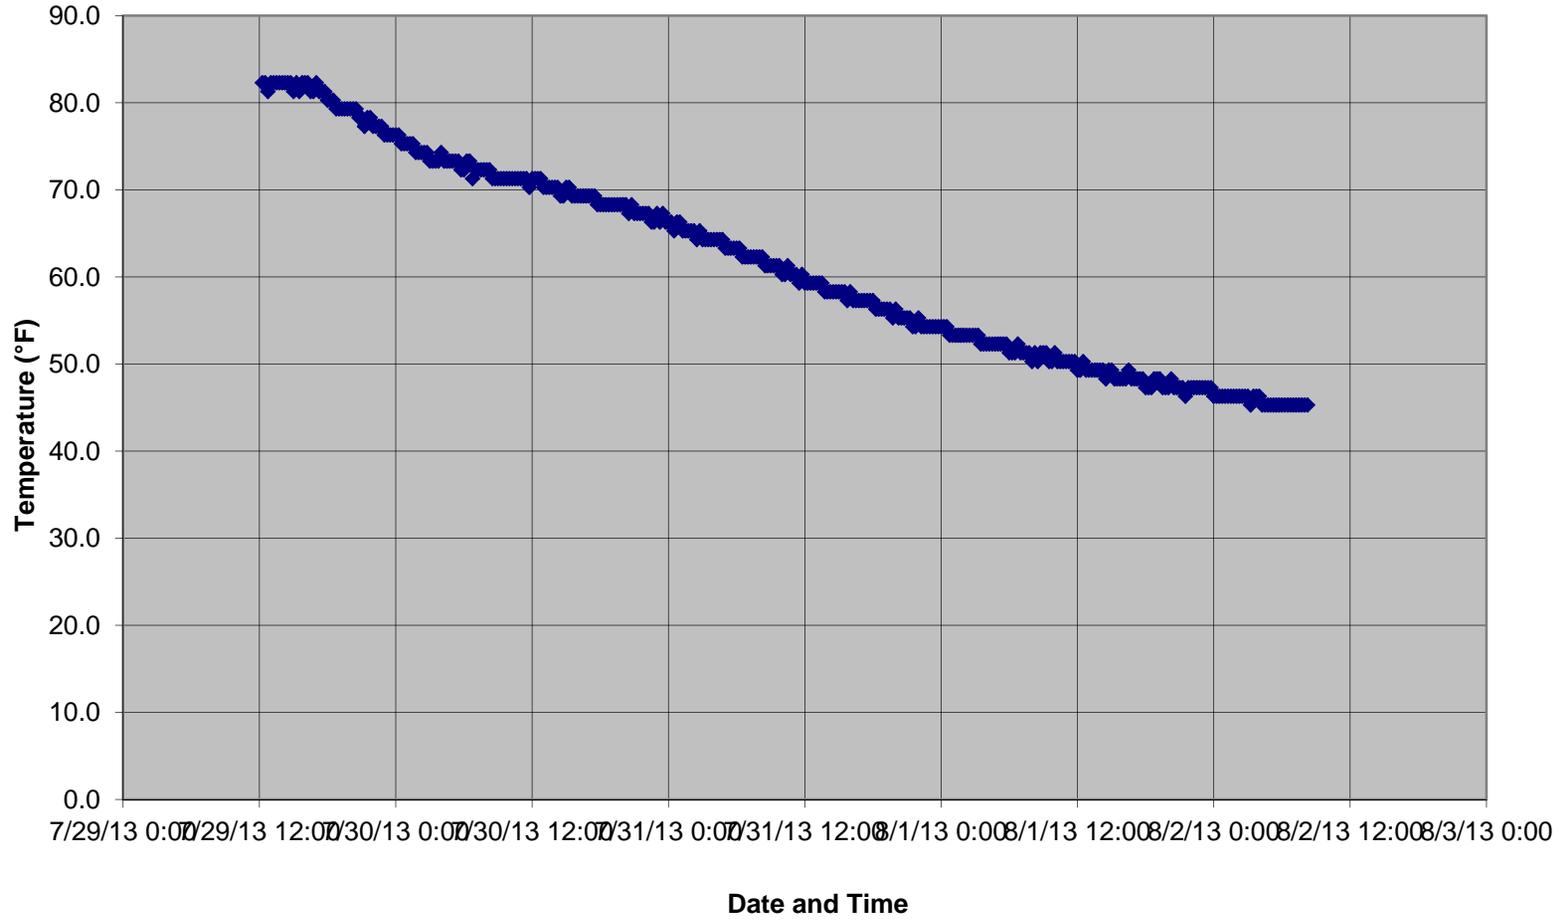
Nomad #3  
Temperature vs Time (°F)

The data analysis above and the graph indicate that the temperature began at approximately 82°F and decreased to approximately 45°F over the course of the testing period. We are unable to determine if the final temperature was at equilibrium. Based on the graph it is possible that the temperature would continue to drop and we would recommend that the test be performed for a longer duration until the temperature stabilizes.

<b>Statistic</b>	<b>Value</b>
Minimum	45.3°F
Maximum	82.3°F
Average	61.5°F
Standard Deviation	11.5°F
Sample Variance	131.7

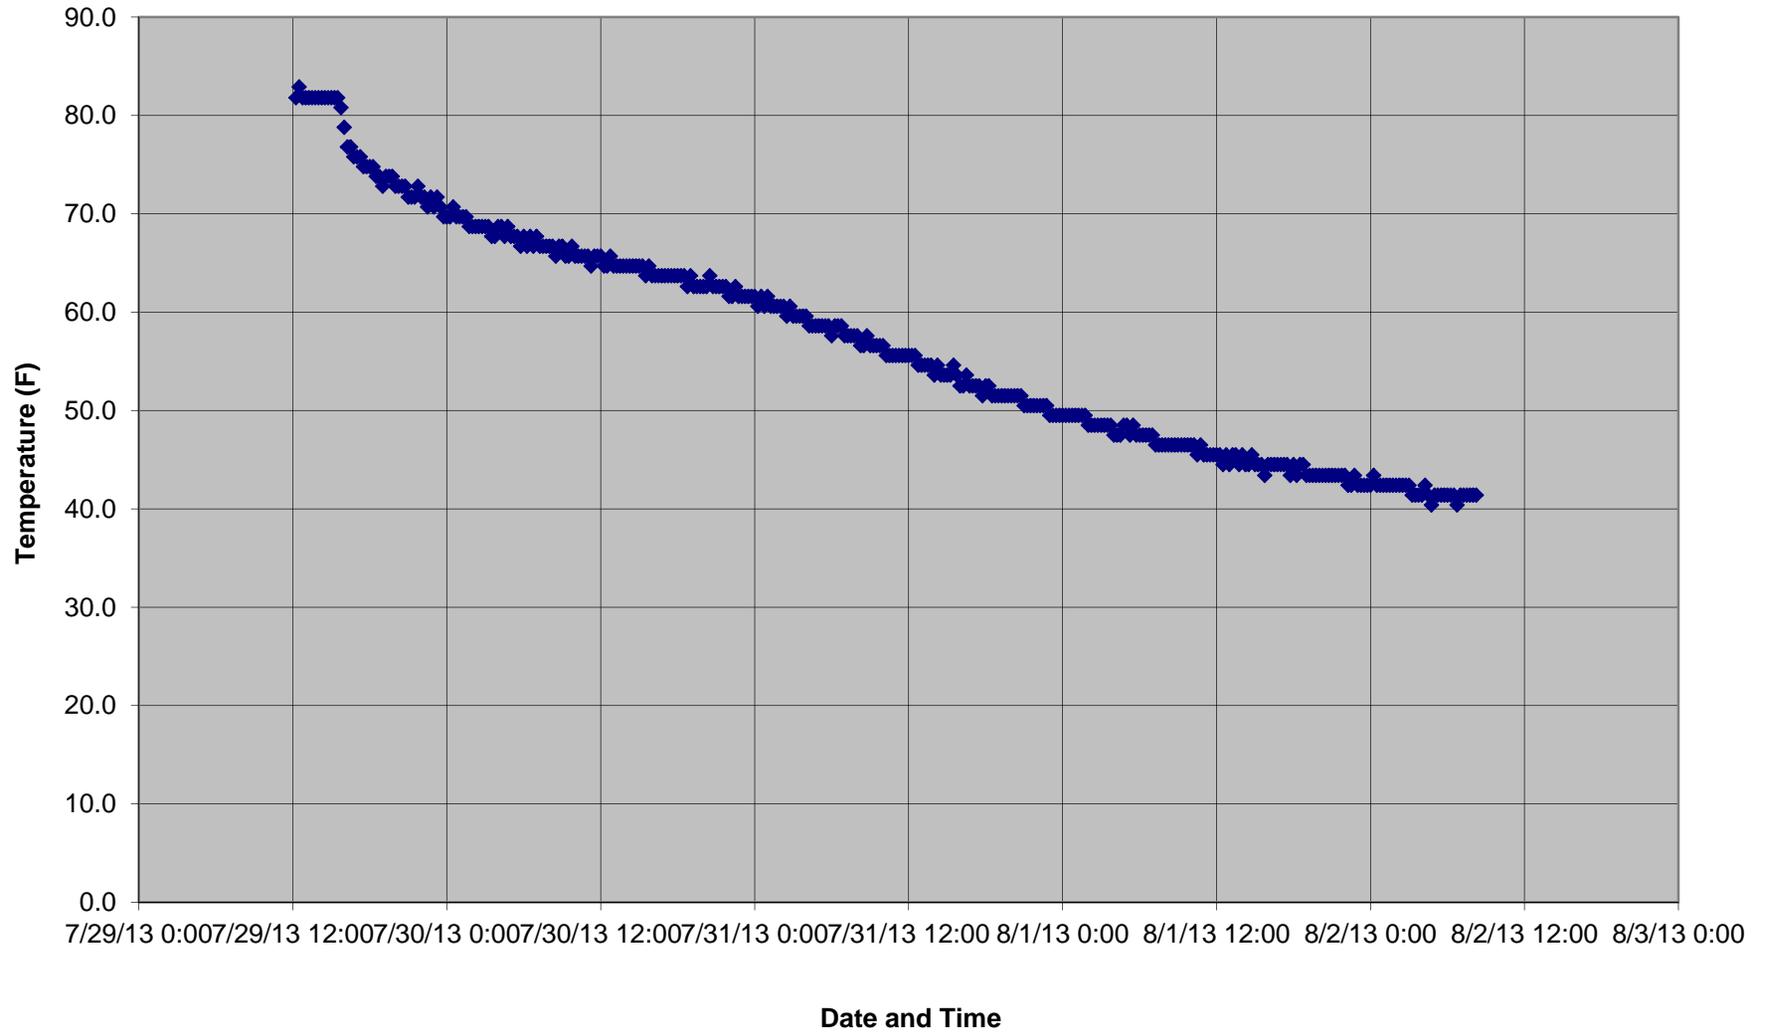
Nomad #4  
Temperature vs Time

The data analysis above and the graph indicate that the temperature began at approximately 83°F and decreased to approximately 40.5°F over the course of the testing period. We are unable to determine if the final temperature was at equilibrium. Based on the graph it is possible that the temperature would continue to drop and we would recommend that the test be performed for a longer duration until the temperature stabilizes.

<b>Statistic</b>	<b>Value</b>
Minimum	40.4°F
Maximum	82.9°F
Average	56.9°F
Standard Deviation	11.3°F
Sample Variance	128.5

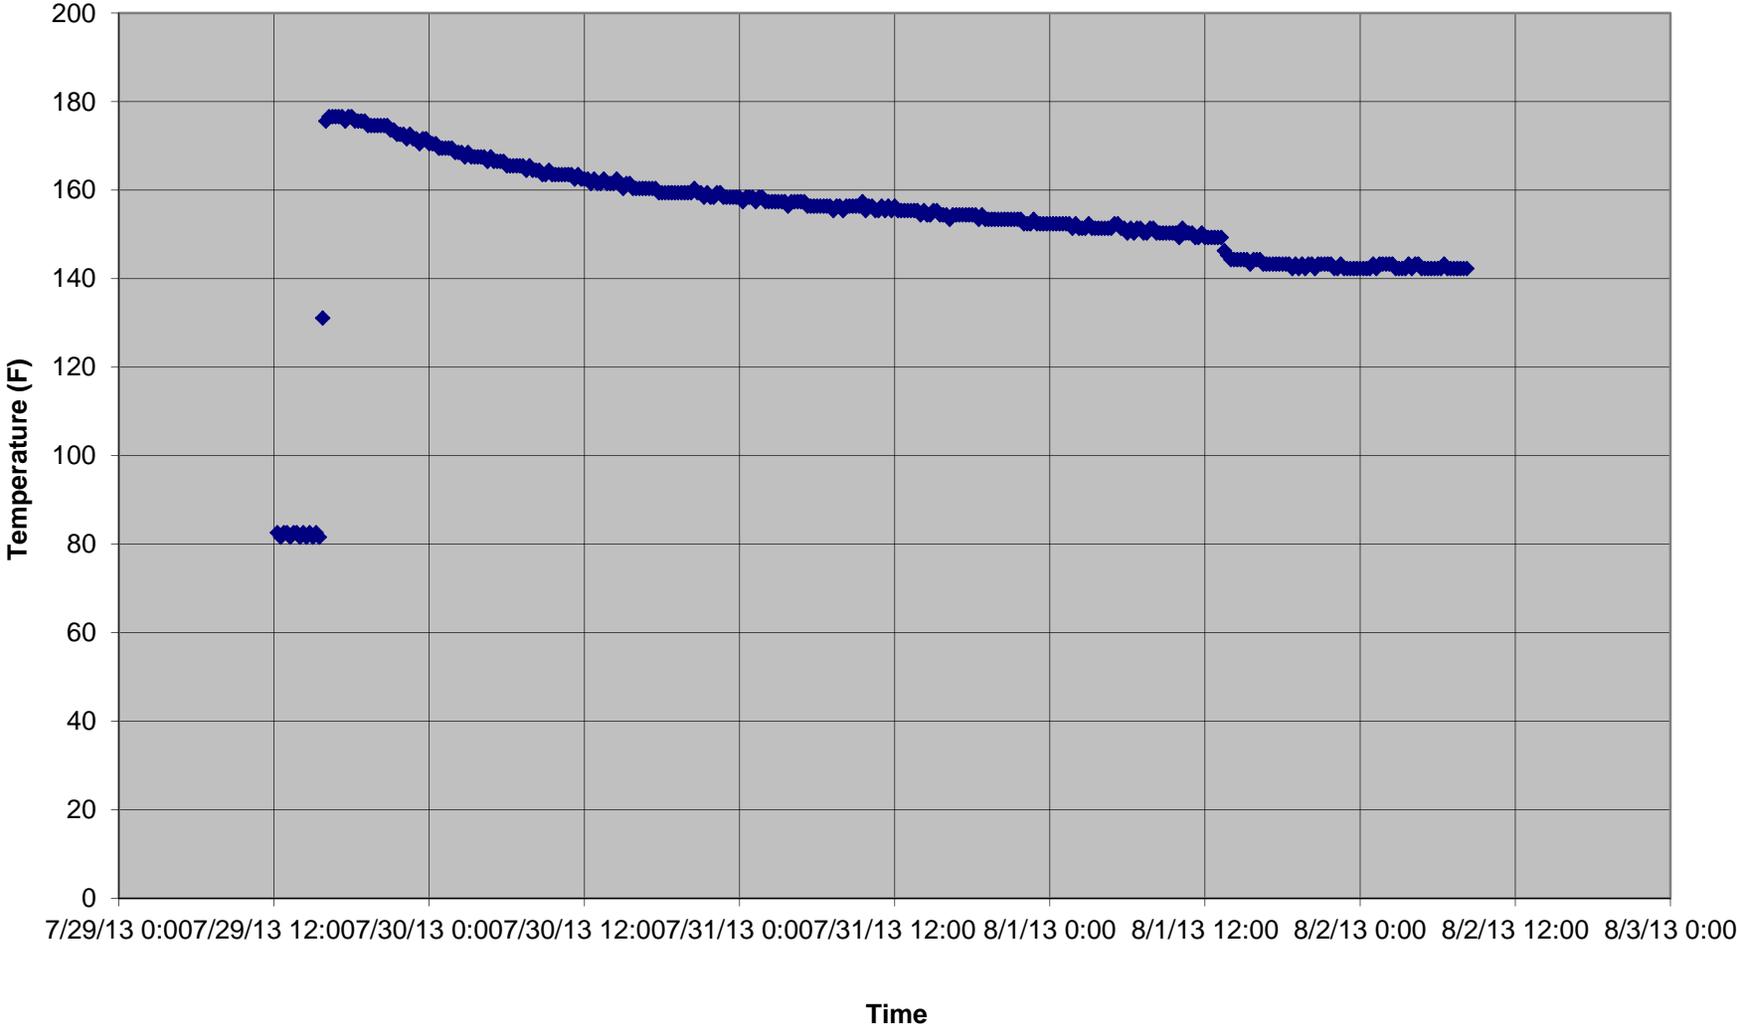
Nomad #6  
Temperature vs Time

The data analysis above and the graph indicate that the temperature began at approximately 82°F and increased to approximately 177°F and then slowly decreased to approximately 142°F over the course of the testing period. We are unable to determine if the final temperature was at equilibrium. Based on the graph it is possible that the temperature would continue to drop and we would recommend that the test be performed for a longer duration until the temperature stabilizes.

<b>Statistic</b>	<b>Value</b>
Minimum	81.6°F
Maximum	176.6°F
Average	153.0°F
Standard Deviation	16.9°F
Sample Variance	286.2

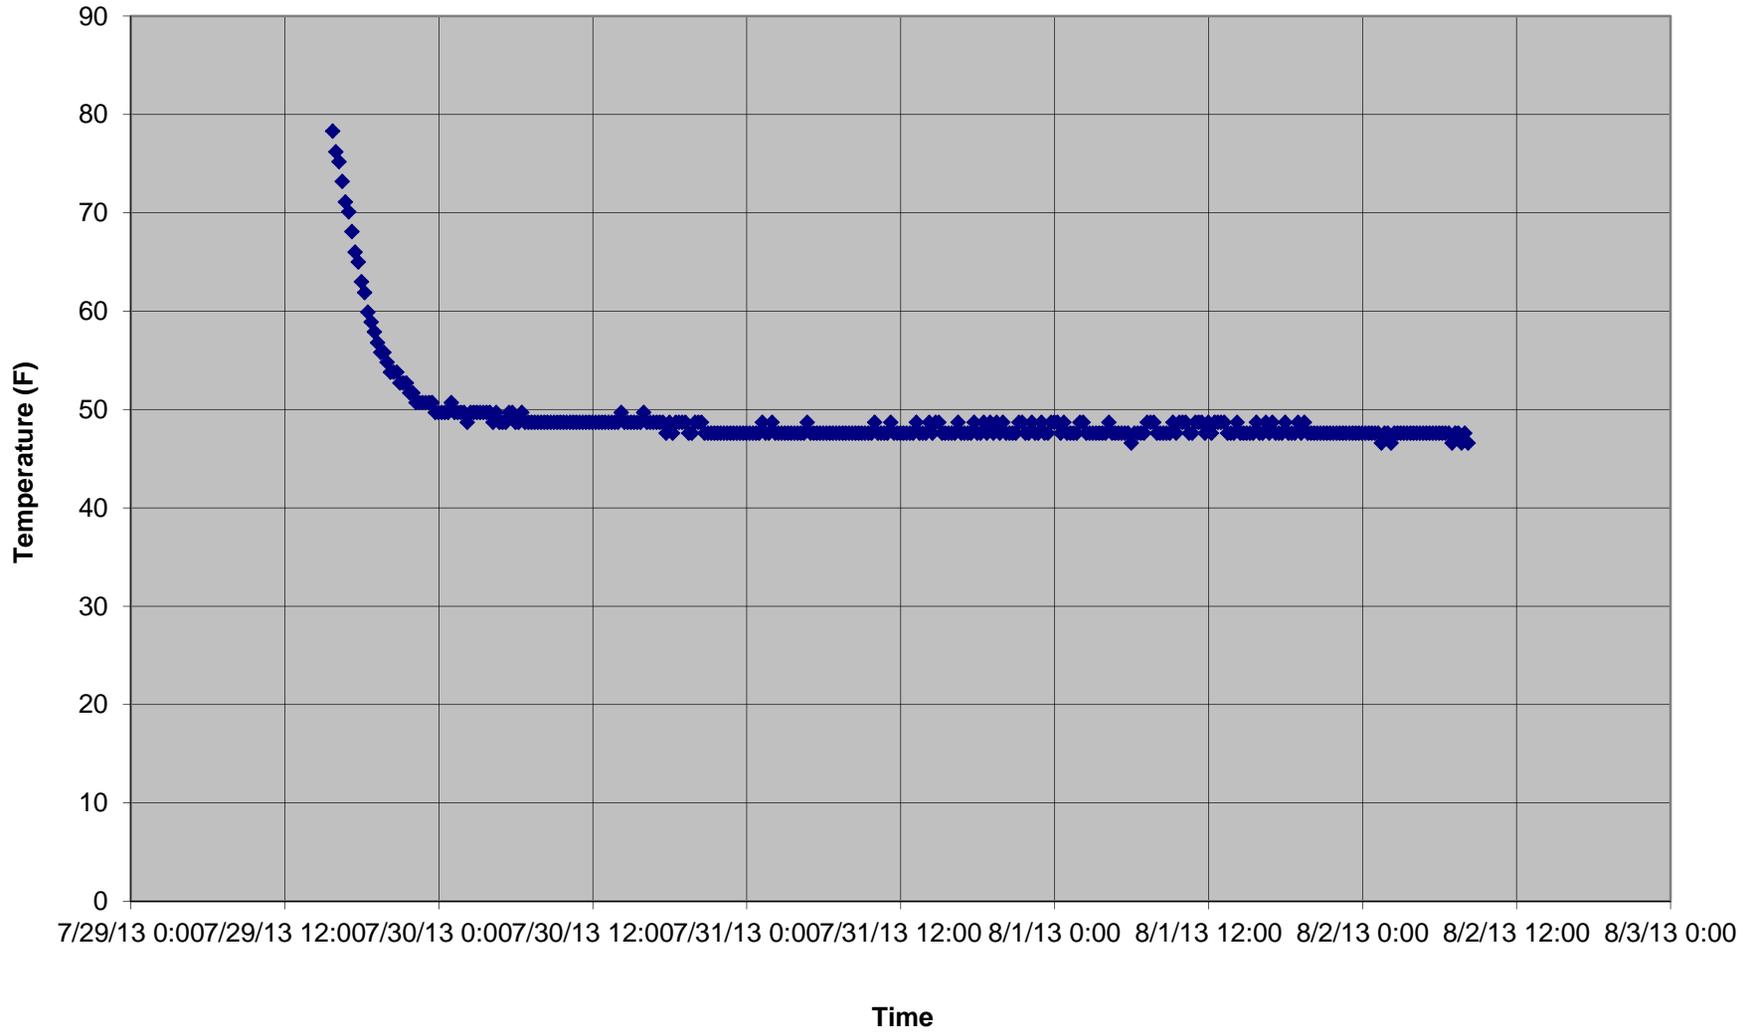
Nomad #10  
Temperature vs Time

The data analysis above and the graph indicate that the temperature began at approximately 78°F, drastically decreased to approximately 49°F, and kept steady for the remainder of the testing period. It would appear that the temperature reached equilibrium by the end of the testing period.

<b>Statistic</b>	<b>Value</b>
Minimum	46.6°F
Maximum	78.3°F
Average	49.1°F
Standard Deviation	4.2°F
Sample Variance	17.3

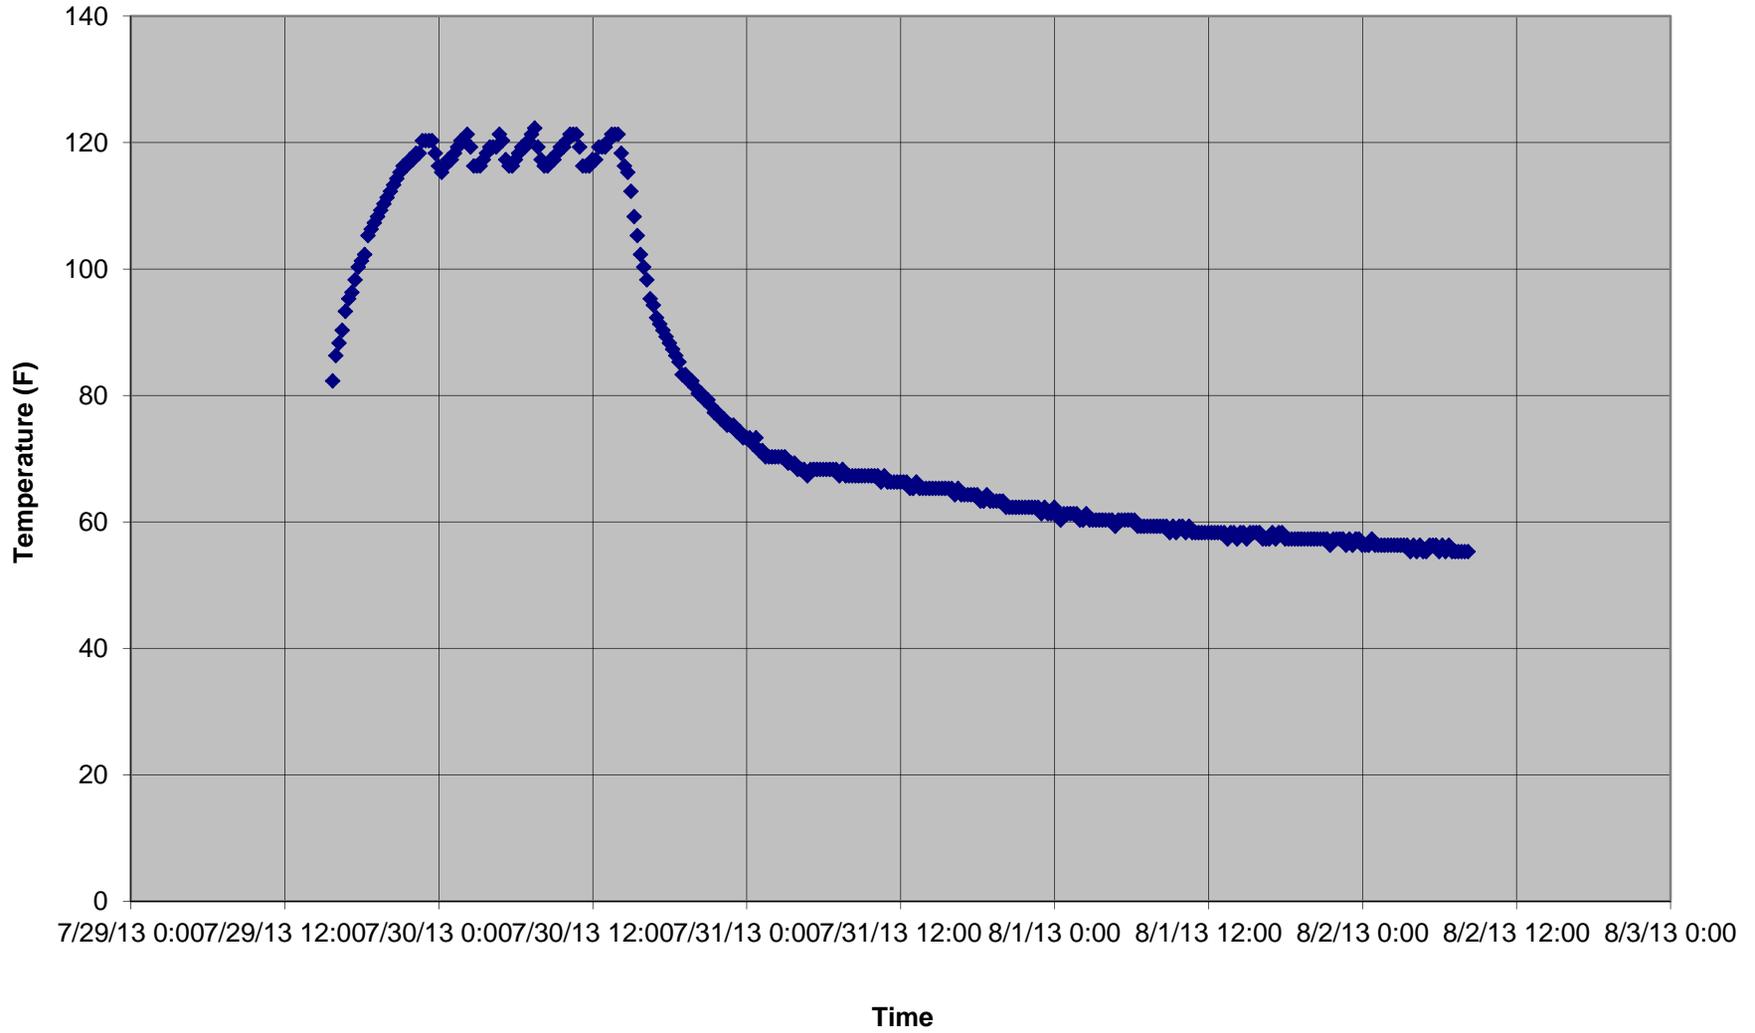
Nomad #11  
Temperature vs Time

The data analysis above and the graph indicate that the temperature began at approximately 82°F and drastically increased to approximately 121°F. It fluctuated for a short period of time and then drastically decreased to approximately 70°F. Once the temperature reached 70°F it gradually continued to decrease until it reached an ending temperature of approximately 55°F. We are unable to determine if the final temperature was at equilibrium. Based on the graph it is possible that the temperature would continue to drop and we would recommend that the test be performed for a longer duration until the temperature stabilizes.

<b>Statistic</b>	<b>Value</b>
Minimum	55.3°F
Maximum	122.3°F
Average	77.9°F
Standard Deviation	24.0°F
Sample Variance	576.8

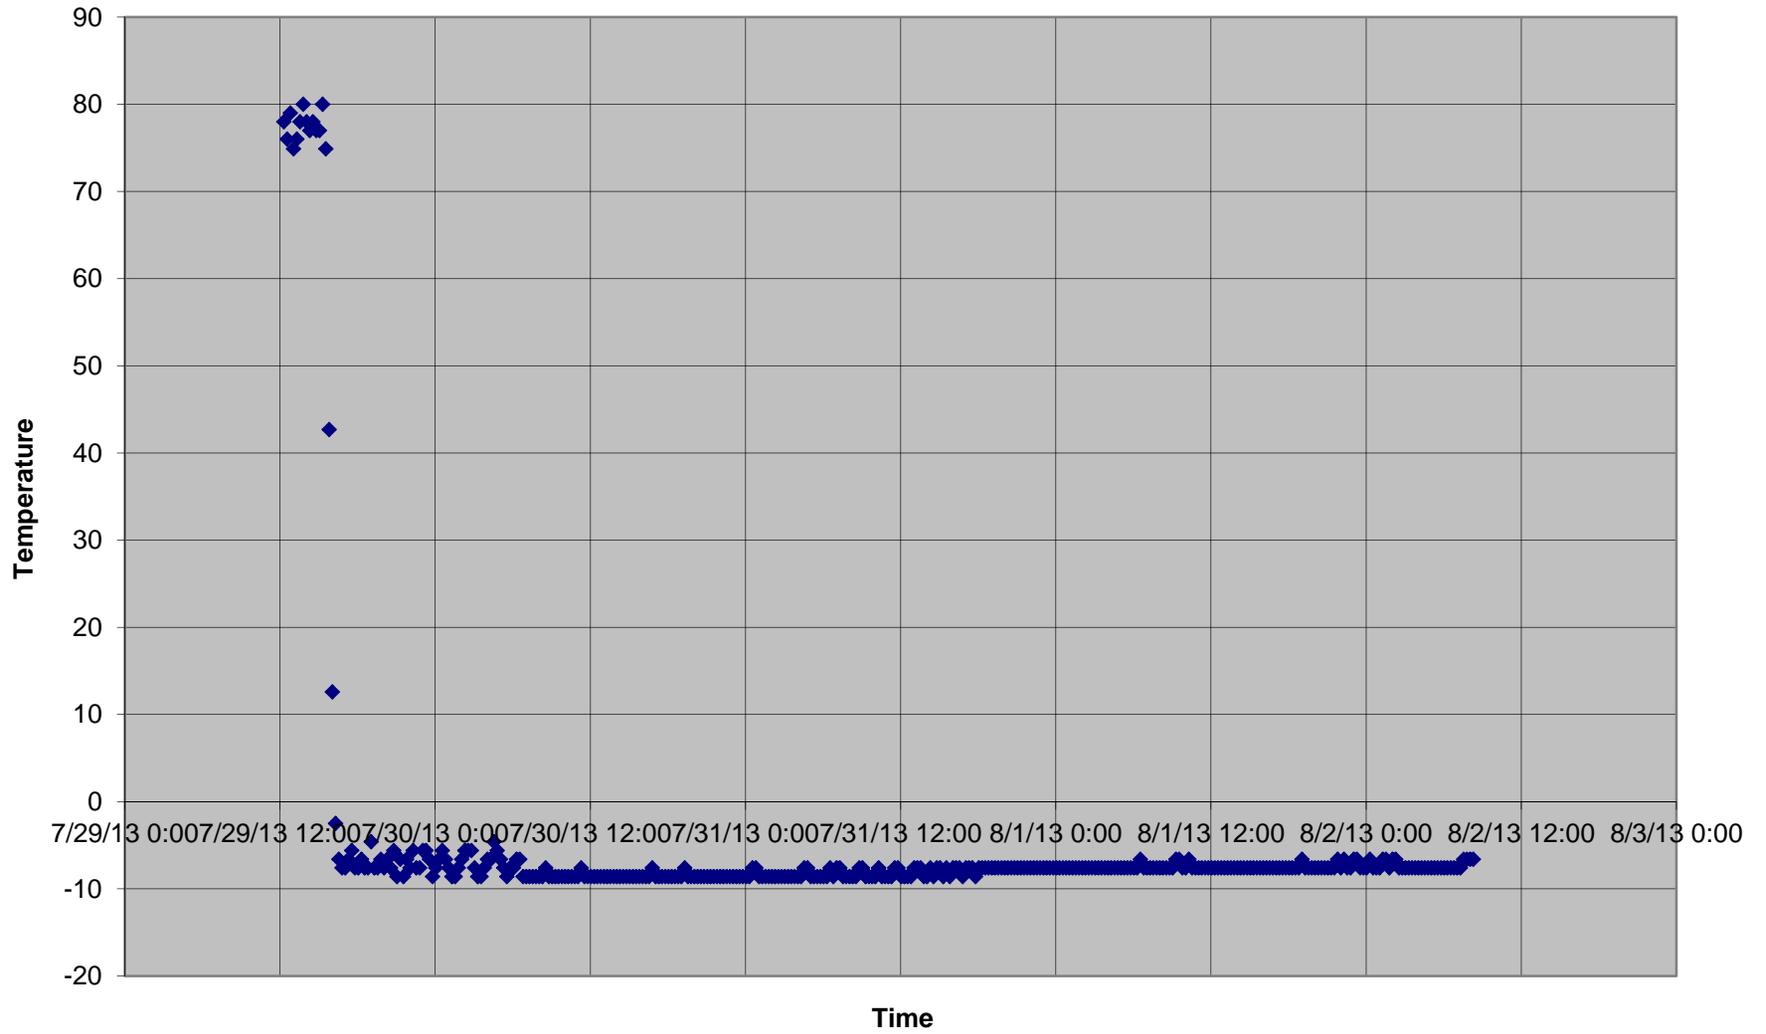
Nomad #12  
Temperature vs Times

The data analysis above and the graph indicate that the temperature began at approximately 80°F and drastically decreased to approximately -7.5°F. The temperature held between -6.0°F and -7.0°F for the remainder of the test.

Statistic	Value
Minimum	-8.6°F
Maximum	80.0°F
Average	-4.3°F
Standard Deviation	16.5°F
Sample Variance	273.0

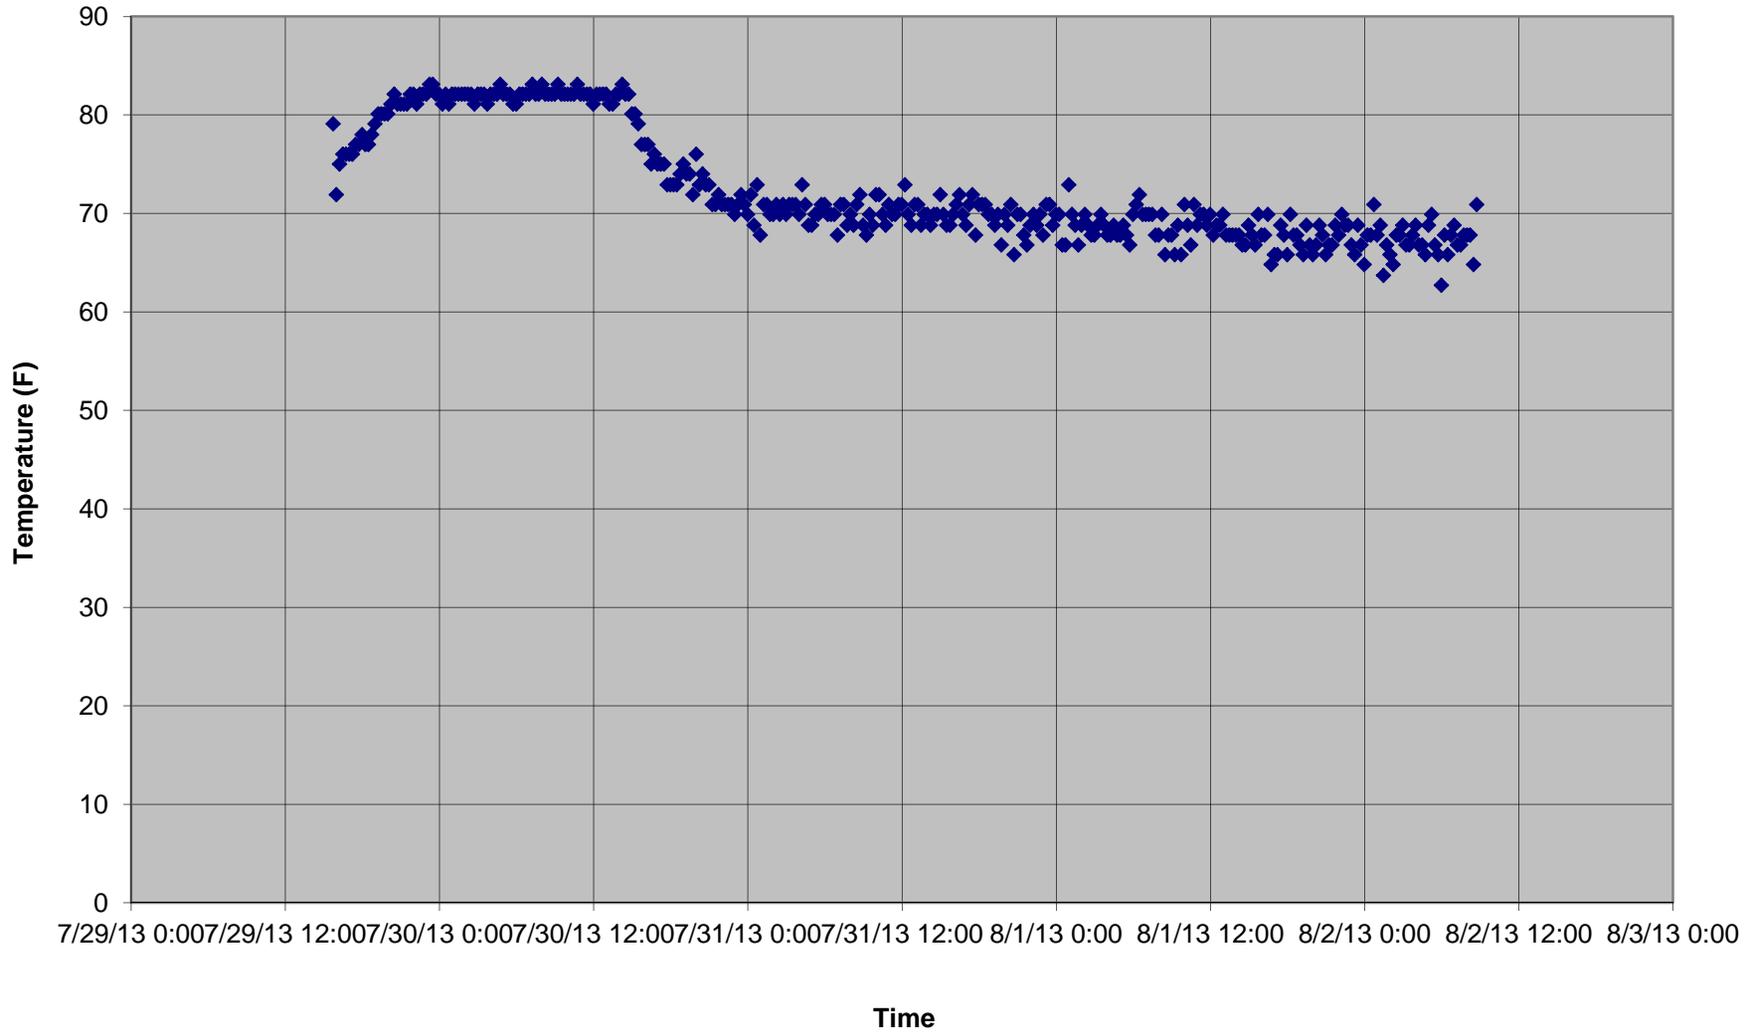
Nomad #13  
Temperature vs Times

The data analysis above and the graph indicate that the temperature began at approximately 72°F slowly increased to approximately 82°F and held for a short period of time. The temperature then dropped slowly and fluctuated 2-3 degrees around approximately 77°F for the remainder of the test.

Statistic	Value
Minimum	62.7°F
Maximum	83.1°F
Average	72.5°F
Standard Deviation	5.7°F
Sample Variance	32.3
