**CORNERSTONE INNOVATIONS, INC.  
CASE STUDY – PERMAFORM  
HOLMES TESTING, INC.  
170 SHEPARD AVENUE  
WHEELING, ILLINOIS**

Re: Summary of Results for the Permaform Case Study, Holmes Testing Laboratories, Wheeling, Illinois

Case Study, Cornerstone, Permaform – Temperature Testing, Wheeling, Illinois

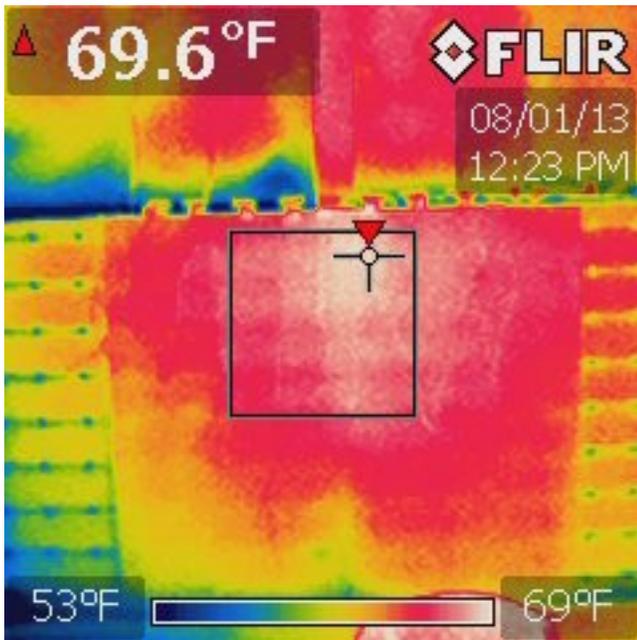
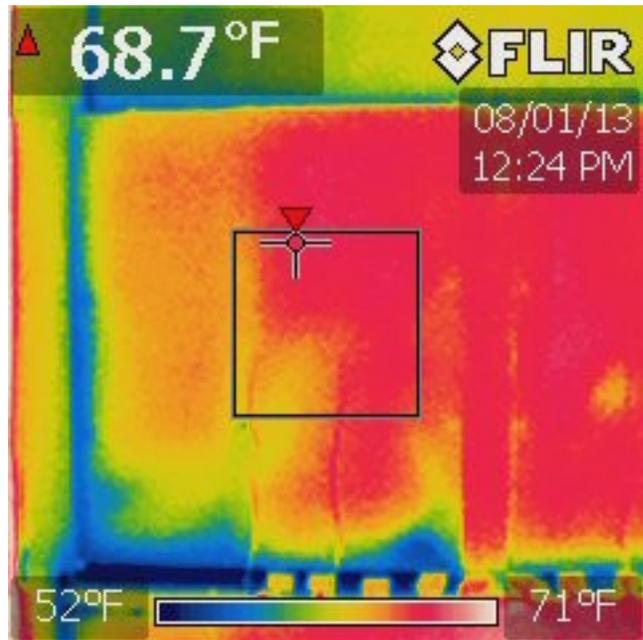
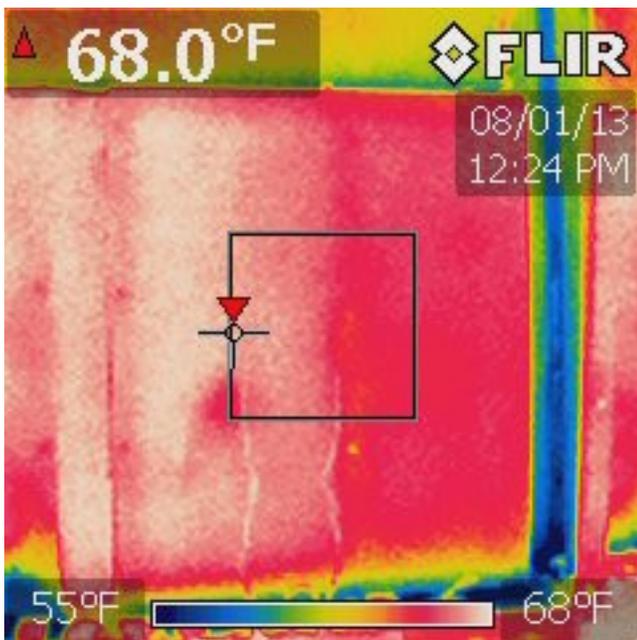
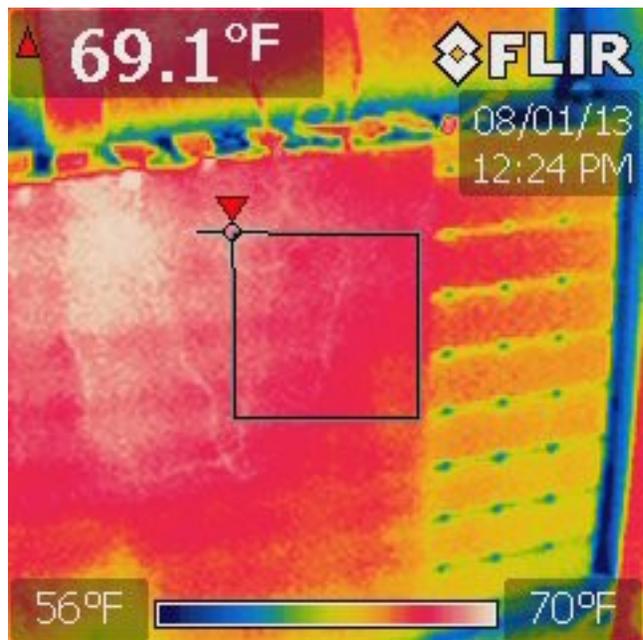
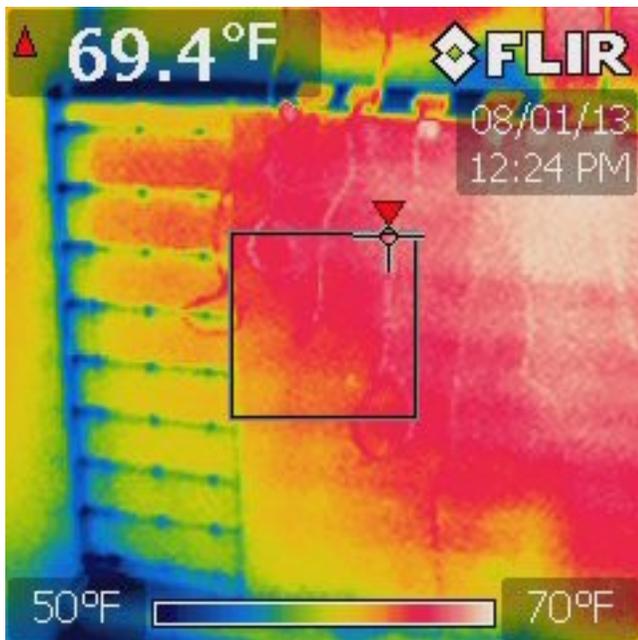
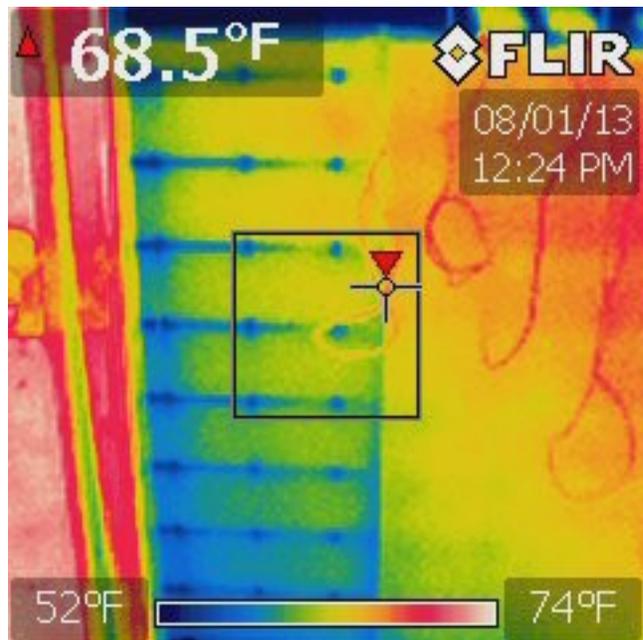
On August 1<sup>st</sup>, 2013 photographs of the wall were taken using an infrared heat camera to show the temperature profile across the wall. Based on these photographs it would seem that the temperatures on the side with the Stucco and rubber coatings were in the range of 65-70 degrees while the temperatures on the bare wall had temperature ranges between 60-65 degrees. See photographs attached in the appendix of this report.
